# Inspection Report

3230 263rd St NW  
Stanwood, WA

2/1/2012

A0201123034

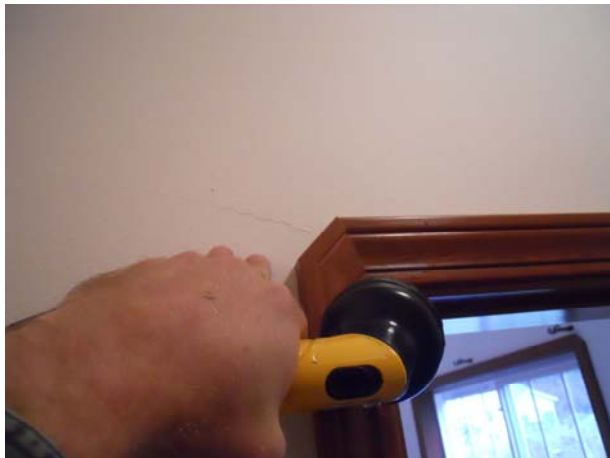
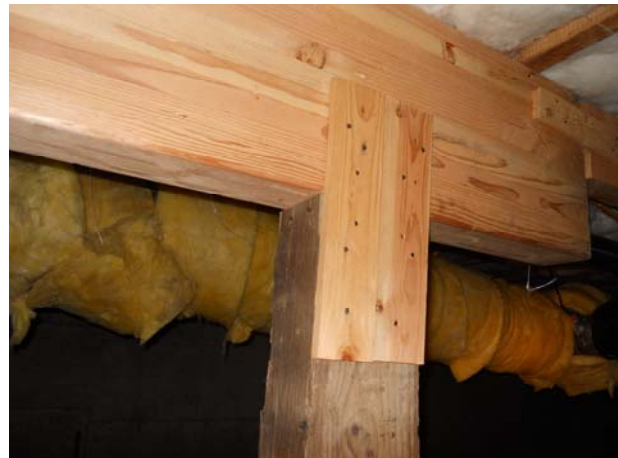
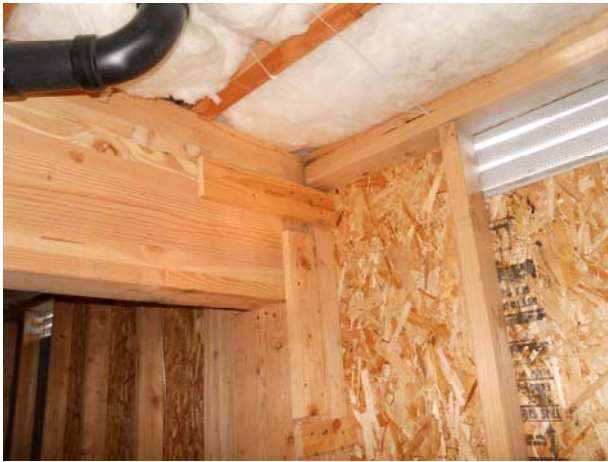
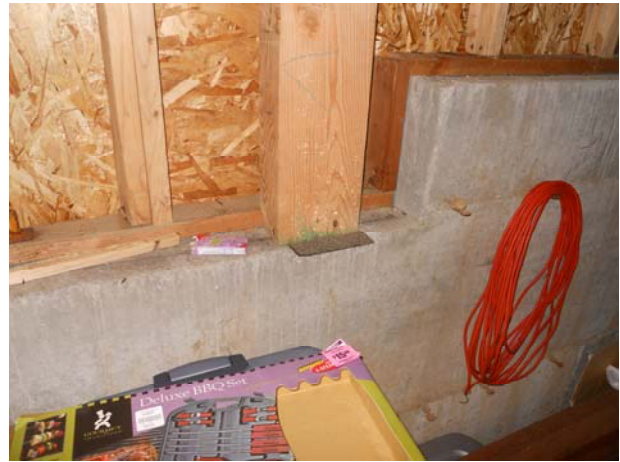
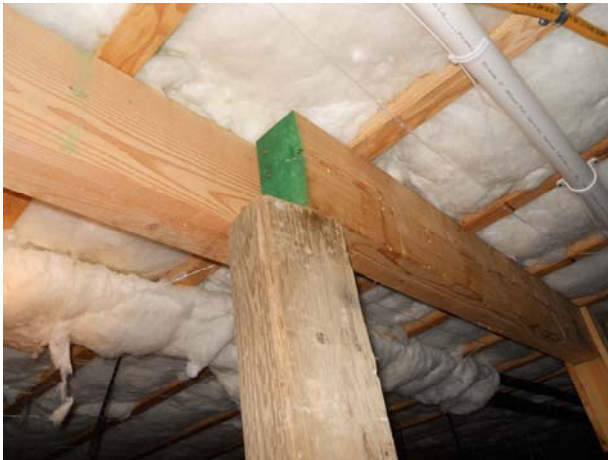
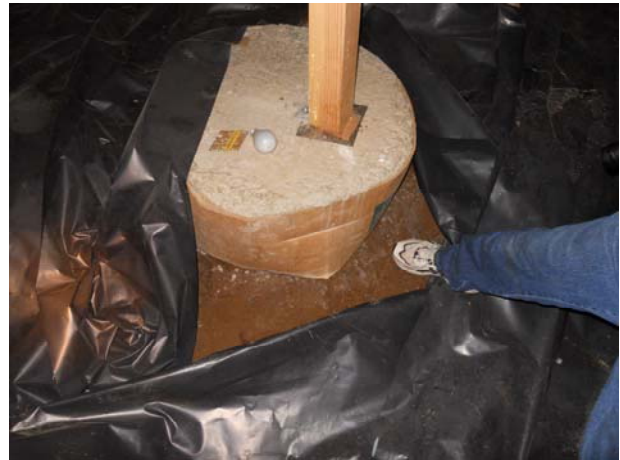
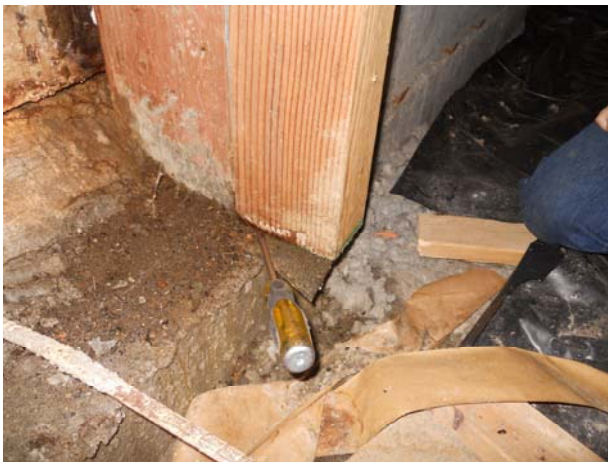
**1. Major Concern, WDO :->** Multiple red flags were noted in the post and footing system for the floor frame beams in the crawl space. I noted a hairline crack in the closet, SE bedroom to indicate some settlement and it could be related to this floor framing system. In the crawl space, positive connections are incomplete especially at the glue lams and posts for these beams. The post on the east side near the crawl space access is getting wet and has marginal bearing - this post should be done in pressure treated lumber and have an adequate footing. One footing roughly below the living room has inadequate bearing soils below - the cone of compression has been disturbed and this is vulnerable to settlement. I also noted multiple bolts that have not been adequately bolted down at the mud sills. Hire a qualified framing contractor to further evaluate and repair floor framing in the crawl space to insure reliable performance and adequate seismic protection.

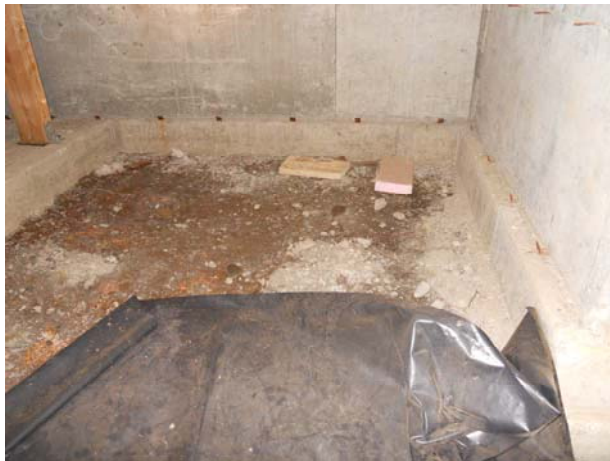
**6. Repair** :-> The plastic vapor barrier in the crawl space is incomplete at the SE corner. Use 6 mil black plastic to cover all exposed earth. This helps to reduce humidity and eliminate conducive pest conditions in the crawl space.

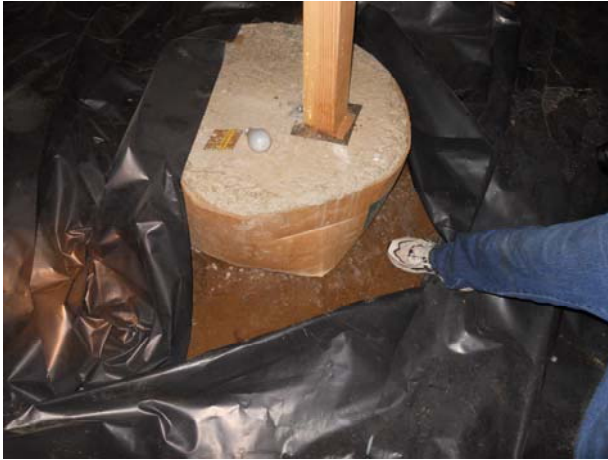
**7. Repair** :-> One of the posts in the crawl space appears to have inadequate bearing - see below the living room where soils slope. As a general rule, the cone of compression should not be disturbed below a footing. This is a 45 degree angle out from the footing where soils should not be disturbed. This is to insure proper bearing soils remain below the footing. have this further evaluated and repaired by a qualified general contractor.

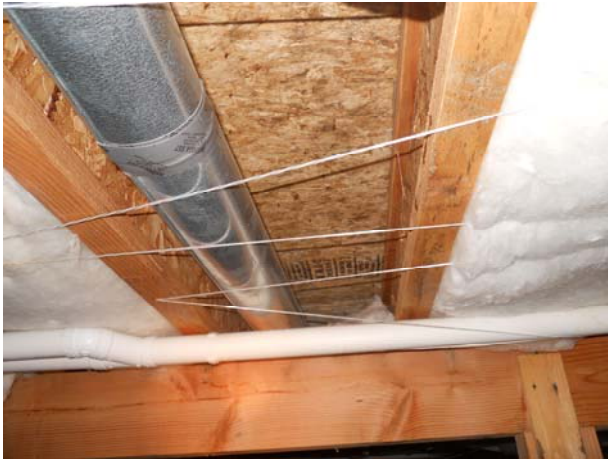
**8. Efficiency Observation** :-> The sub-floor insulation is incomplete and requires repair. Be sure the entire sub-floor is insulated to R-30 or better. When making repairs it is best to seal any noticeable air leaks between the crawl space and the living space. Check all penetrations through the floor.

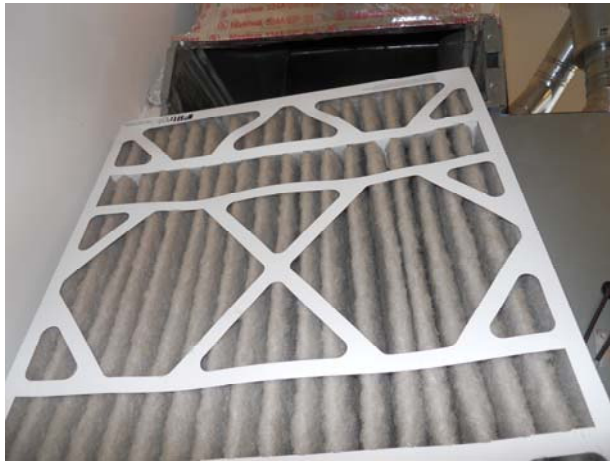
**13. Repair :->** Annual servicing of the heating and cooling system is recommended for safe and reliable operation. Records indicate that this heating and cooling system has not been serviced in the last year. The system was tested during inspection and appeared to be operational. No red flags were noted. System was tested in heating mode with heat pump on. Air filter was dirty and needs to be replaced. Hire a licensed heating contractor to service and further evaluate this system.

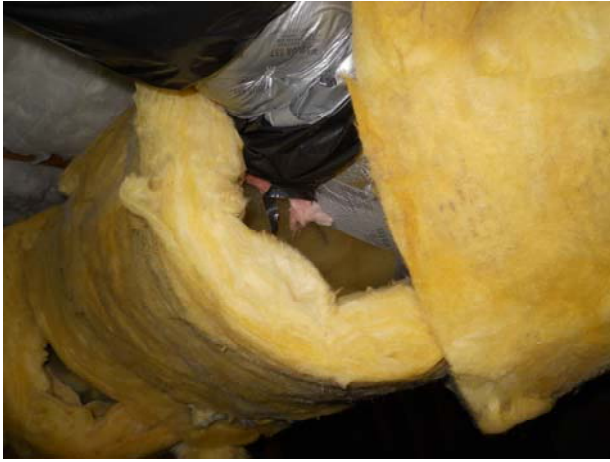
**14. Efficiency Observation :->** The ductwork in the crawl space was noted to be leaky and should be sealed to improve indoor air quality and improve the efficiency of the heating system. Use duct mastic to seal all leaks and be sure all ducts are insulated to R-8 or better - I felt lots of air leakage behind the plenum in the garage when I was in the crawl space and insulation was visibly coming loose in several places.

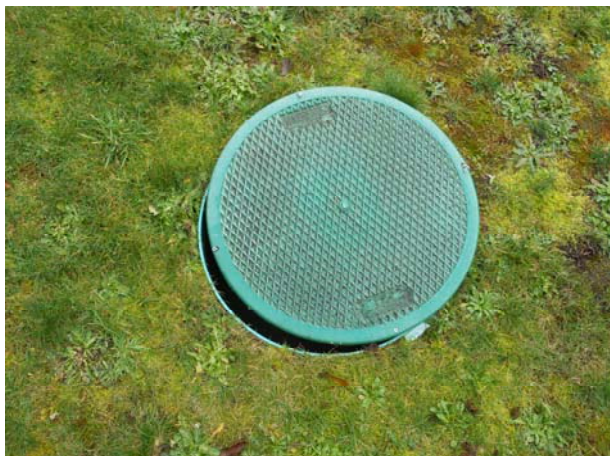
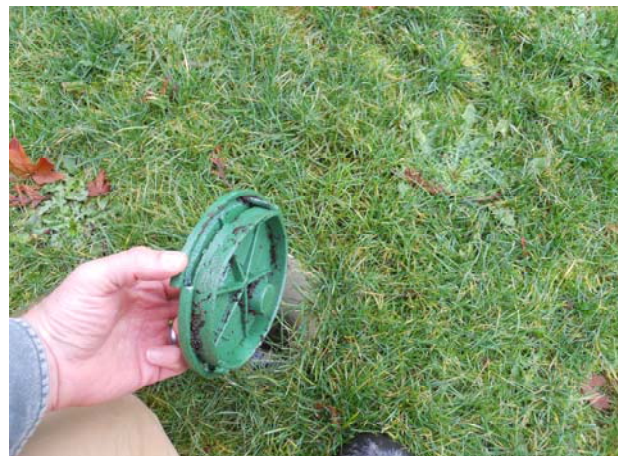
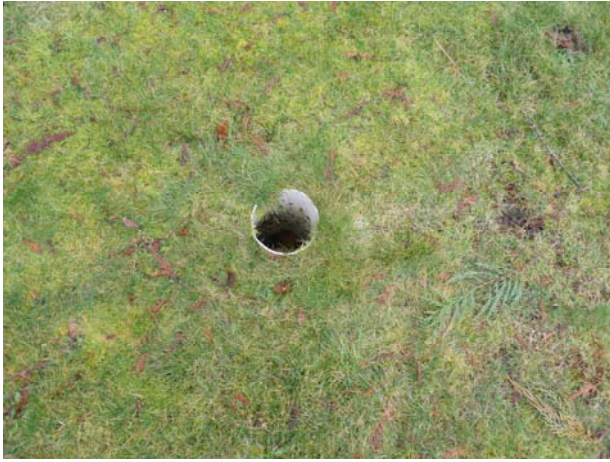
**19. Repair :->** This home's sewage appears to employ a private septic system. Please note that an evaluation of this system is beyond the scope of this inspection. I recommend having this system further evaluated by a septic specialist. I did note when walking the yard that several of the caps for the drain field appear to be damaged and the cover on the east side is damaged and unsecure. Implement repairs to this system as recommended by a specialist.

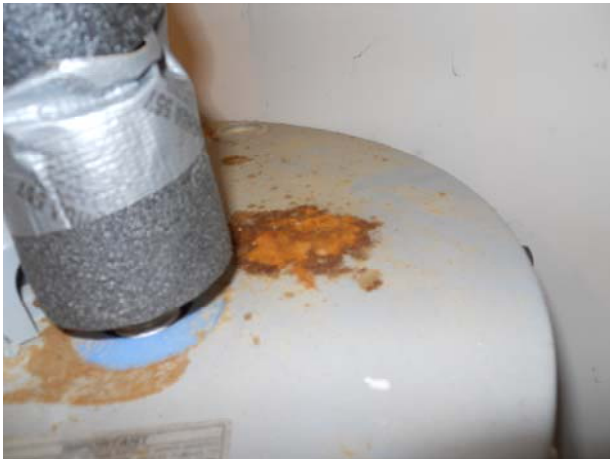
**20. Monitoring Item** :-> Corrosion was noted on the top of one of the water heater tanks. I could not find a leak during inspection - I am uncertain where this water was coming from. Monitor as there could be some intermittent leakage.

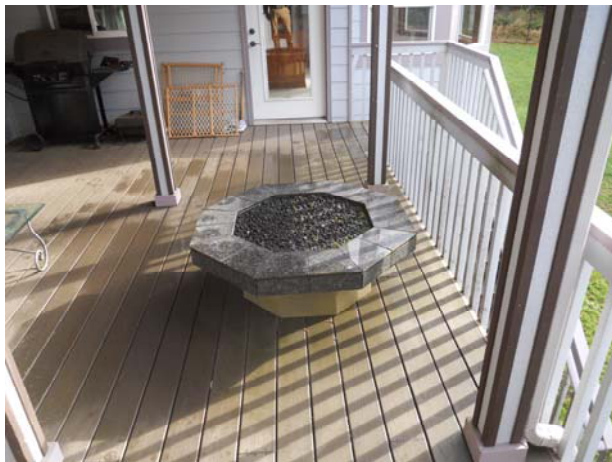
**24. Repair** :-> The gas fireplace on the back deck appears to be in poor condition: pipe leading to the fireplace is corroded, tile around the fireplace is cracked and the materials are saturated below. If you wish to use this I recommend checking clearance to combustible information from the manufacturer: the eaves for the house are directly above this fireplace. Given the visible condition of this appliance I would consider removal. Please note I did not light the appliance as lighting gas appliances by hand is beyond the scope of this inspection. I did find a gas shutoff outside at the appliance.

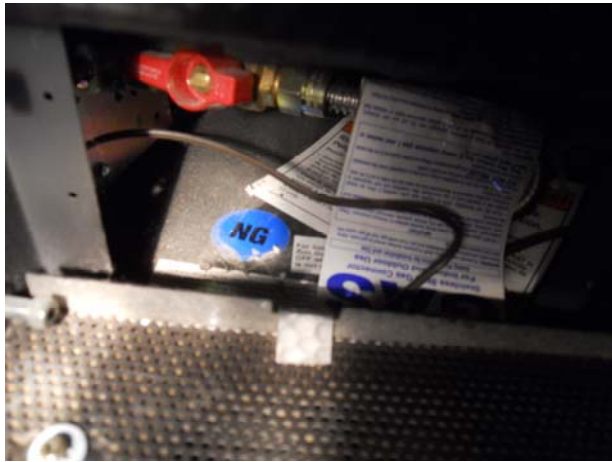
**32. Repair :->** The gas log fireplace in the office had a NG sticker inside indicating it is rated for natural gas and not LP - propane. Have this fireplace serviced and repaired and / or properly labeled as needed to insure the proper burner is installed and it is correctly labeled for propane use.

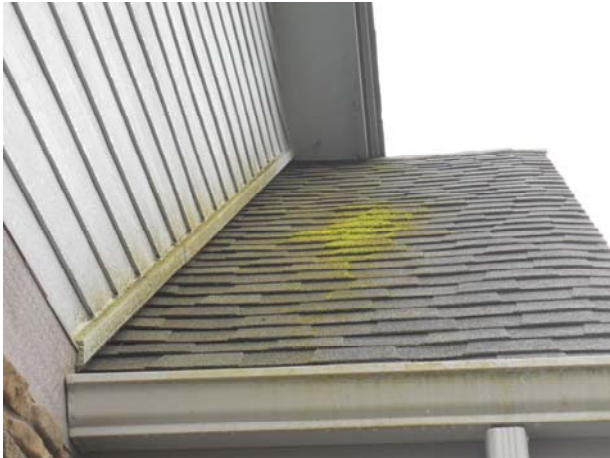
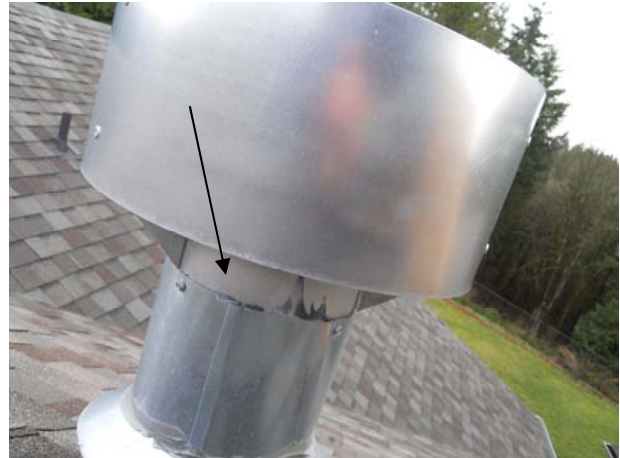
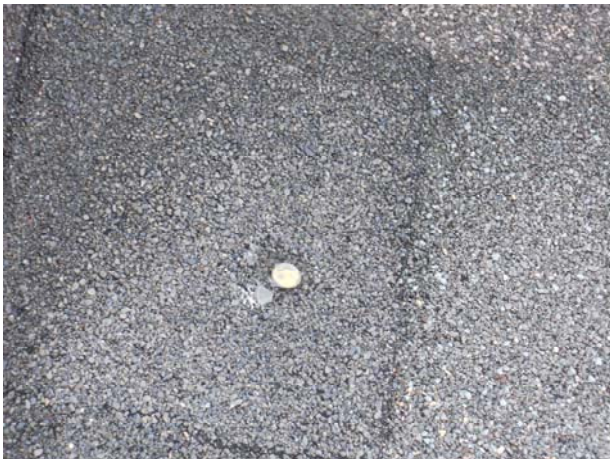
**33. Repair ->** The roofing material on this home appears to be a 6 year old dimensional or architectural grade shingle. These are often rated as 25 or 30 years roofs. In practice I find these last closer to 15-20 years depending on the steepness of the roof and the amount of exposure and quality of the fastening. The installation appears neat and professional but a few repairs are needed: all exposed fasteners should be re-sealed and the Kingsman chimney flue seal should be checked: this pipe is not sleeved in a weather proof fashion and could pose leak problems. Also, implement a moss treatment on north face. Hire a licensed roofing contractor to further evaluate and make tune-up repairs and inquire with the seller about any warranty information for this roof. Many professional roofing companies will offer limited workmanship warranties.

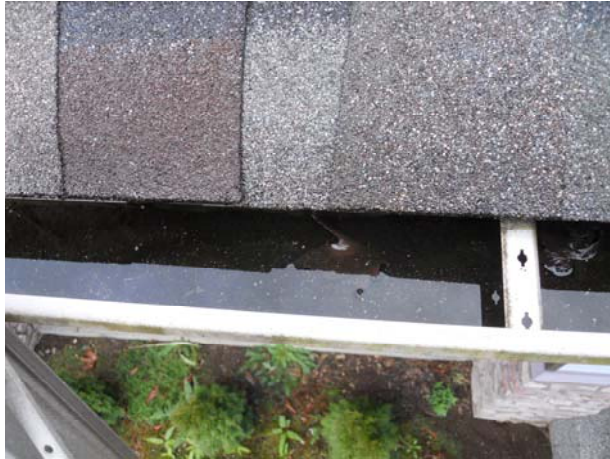
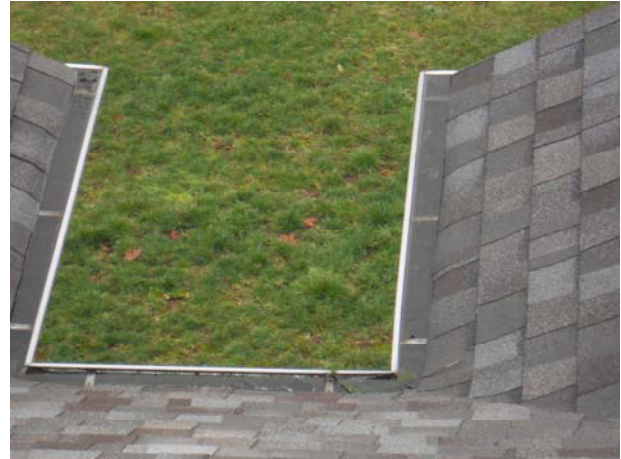
**34. Repair, WDO** :-> The gutters are clogged with organic debris and require cleaning. Hire a gutter specialist to clean the gutters and insure they are properly sloped to drain. Seal up all leaks once gutters are clean and properly sloped to drain. Also be sure to secure all loose downspouts - see south side where downspouts are loose and poorly connected.

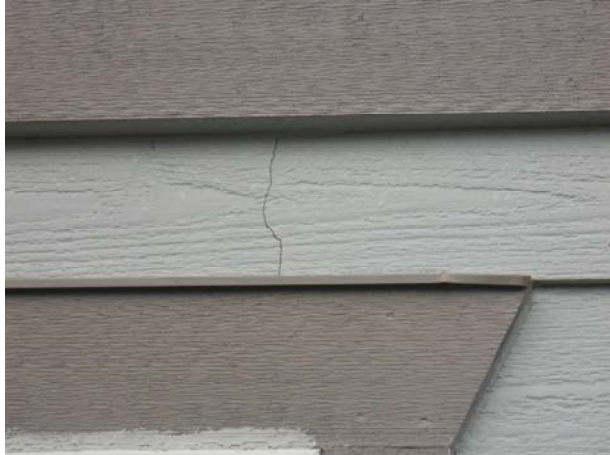
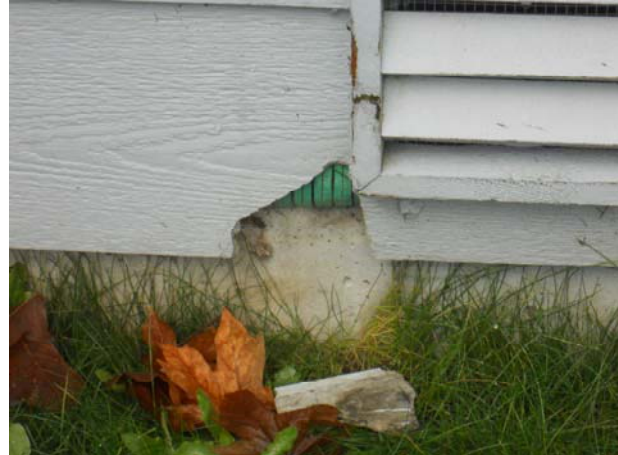
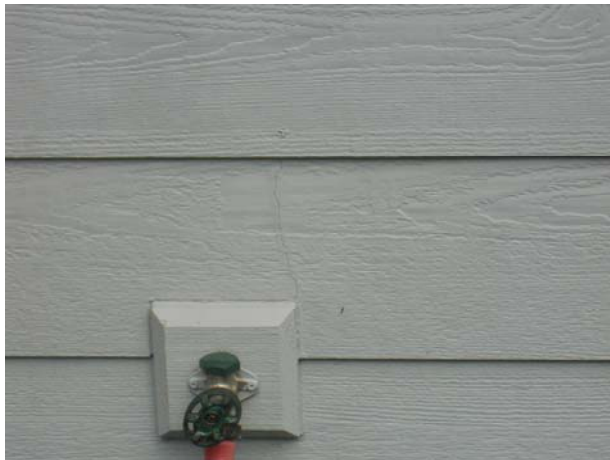
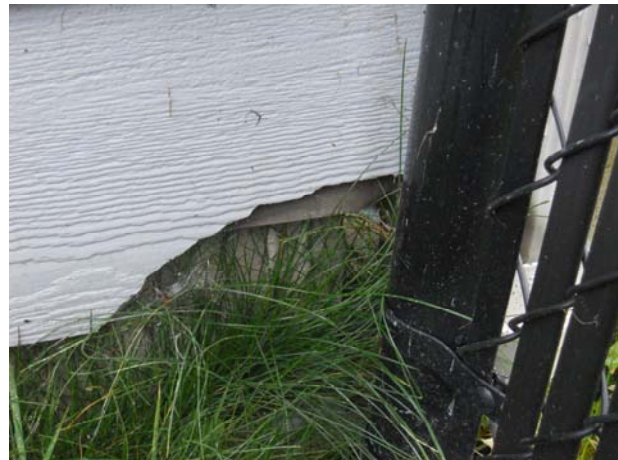
**35. Repair, WDO :->** A number of siding boards on this house are cracked and / or damaged. See east side and west side where the most cracked and damaged boards were found, also a few on the master bedroom deck side. Seal all cracked siding with caulking, re-paint and monitor. This is likely an indication of incorrect siding installation where boards have inadequate space to expand and contract. As the problem seems limited in scope to date, caulking and painting is the most cost-effective repair.

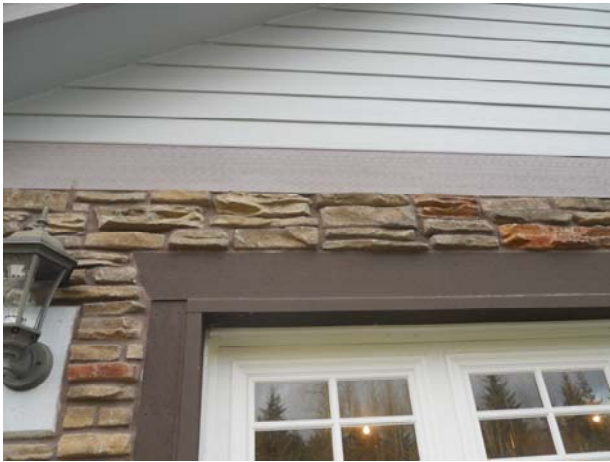
**36. Monitoring Item, WDO :->** Head flashings were not used at the horizontal junctures between the belly trim and cultured stone on the front of the house. Best practices are to flash all horizontal transitions. This could lead to water damage. This will not be cost effective to correct at this time. Hopefully it will perform OK as it is on north side and moderately protected by overhanging eave.

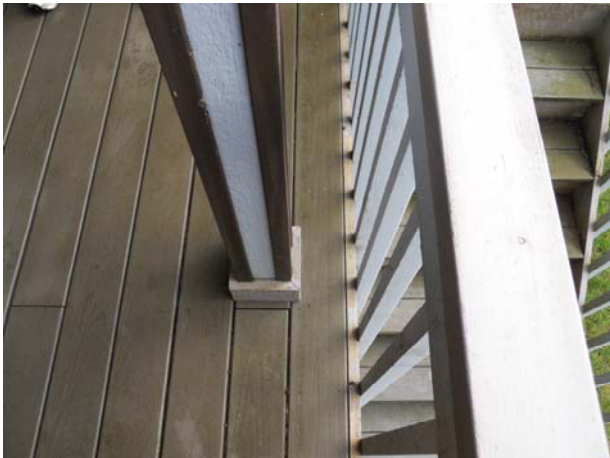
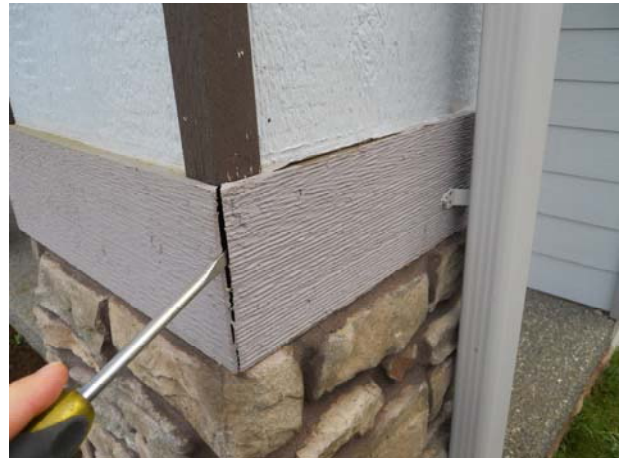
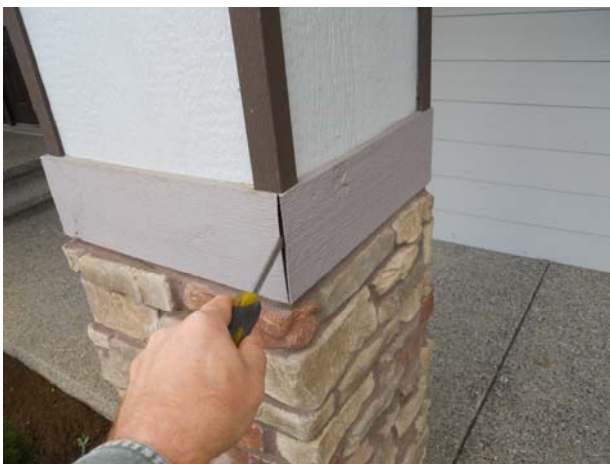
**37. Repair, WDO :->** The columns in the front and back of the house are poorly designed and will be vulnerable to wood rot and decay. In front - see how miters are splitting open, no flashings have been installed for horizontal junctures and no ventilation has been provided for hollow cavities. Implement caulk and paint touch up for columns and install ventilation for front columns to improve dry potential.

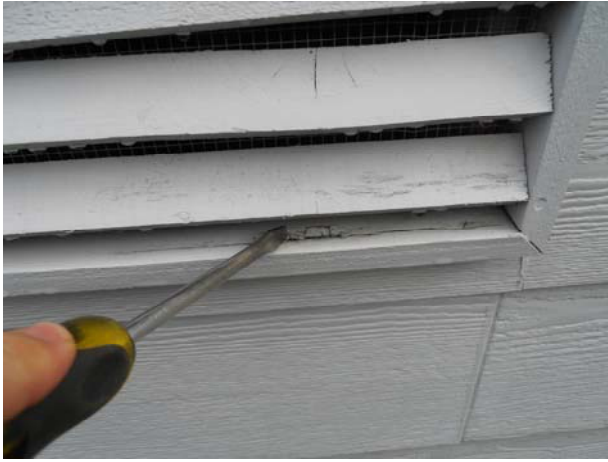
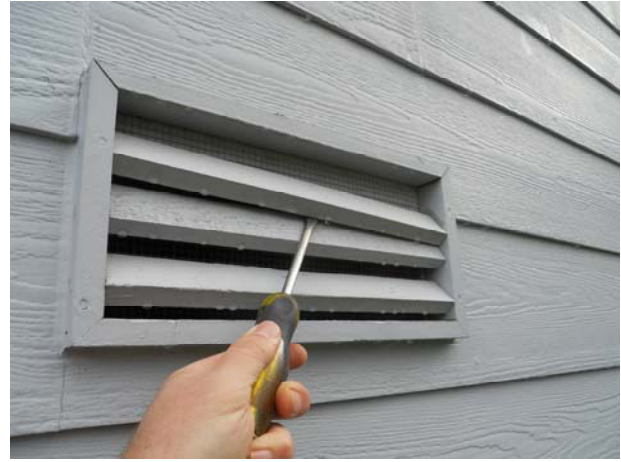
**38. Repair, WDO :->** Several of the crawl space vents on west side are rotted and damaged and require replacement.

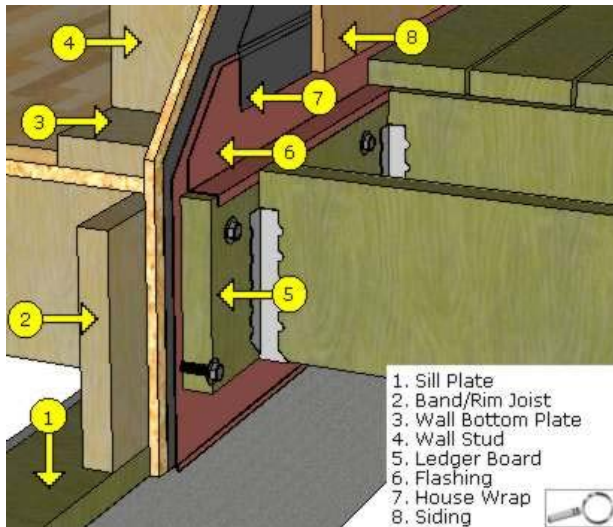
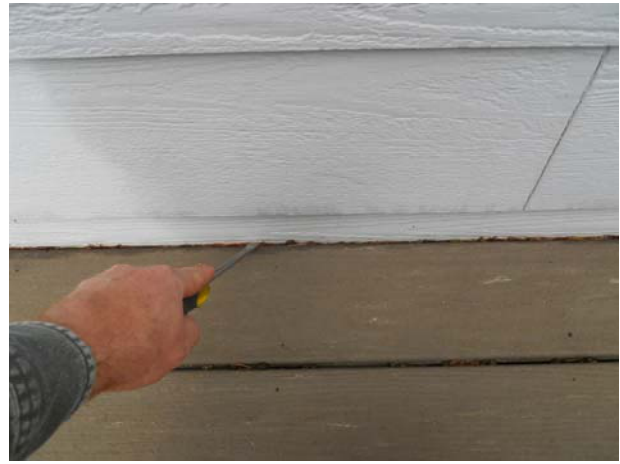
**41. Repair, WDO** :-> Non-standard flashings were noted between the deck ledger board and the home. This could allow water to get trapped between the deck and the house, causing rot and a conducive pest condition - see how the siding is pinned against the decking by the master bedroom. Hire a licensed general contractor to further evaluate and repair.

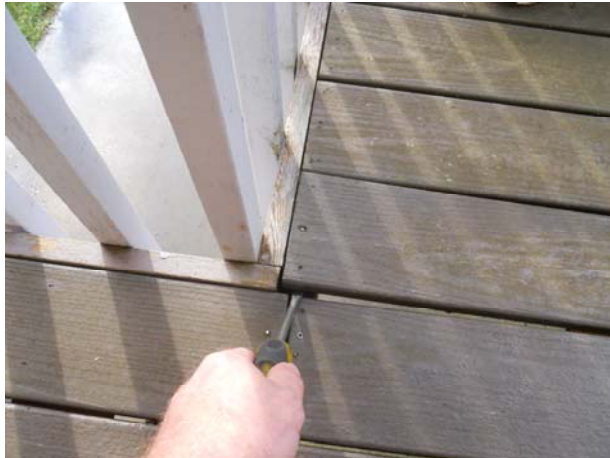
**42. Repair** :-> Several loose decking boards were noted on the deck - secure all loose boards with proper decking screws.

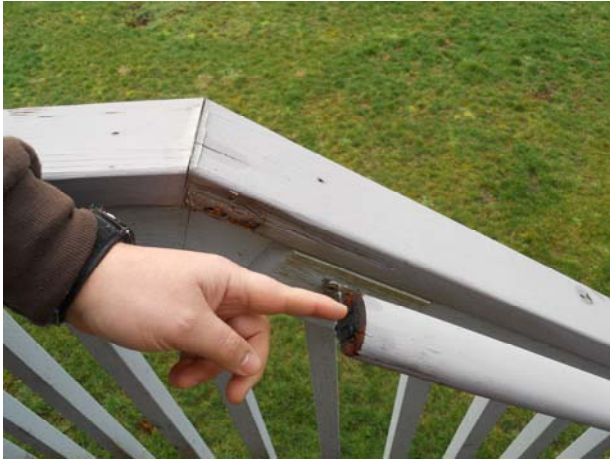
**43. Repair, WDO** :-> Localized wood rot was noted in the railing system for the deck stairs and the handrail is damaged at the top landing - see how return is missing. The entire railing also needs to be painted and loose posts secured. Implement rot repairs and painting repairs to handrail system for this deck.

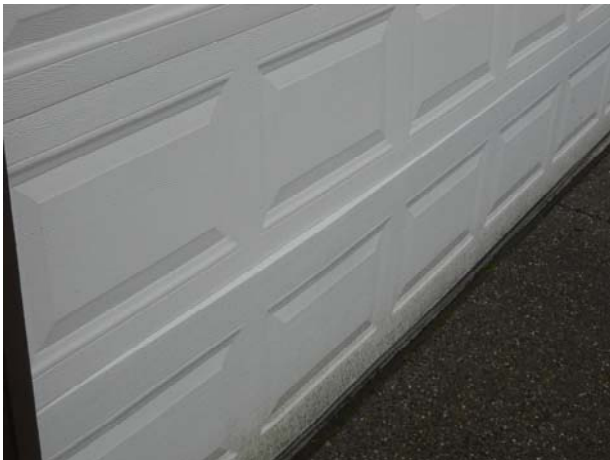
**45. Repair** :-> The double overhead garage door is dented and damaged and requires repair or replacement. Hire a garage door specialist to further evaluate and repair.

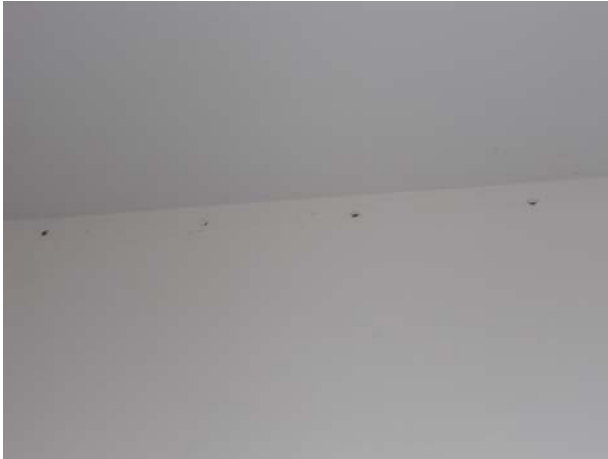
**47. Repair :->** Repair the damaged sheetrock at the back wall of the garage - see at the east side where the top of the sheetrock has multiple nail pops.

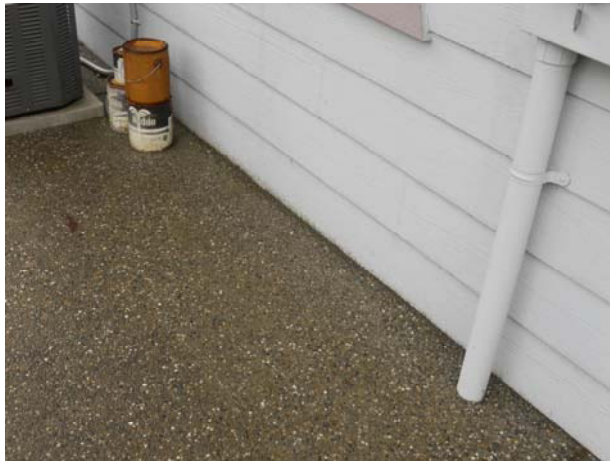
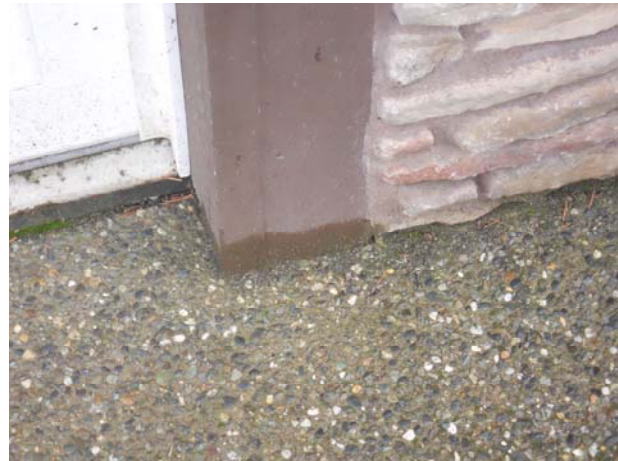
**49. Repair, WDO :->** Siding to concrete contact was noted around the garage. This is a conducive pest condition and there is a chance of hidden water damage behind the concrete as this configuration can trap water against the home. Where possible, an air gap should be provided between the concrete and the house to keep the wood dry. Generally a 2 inch clearance is recommended between siding and hardscape. This may be difficult / not cost effective to correct at this time.

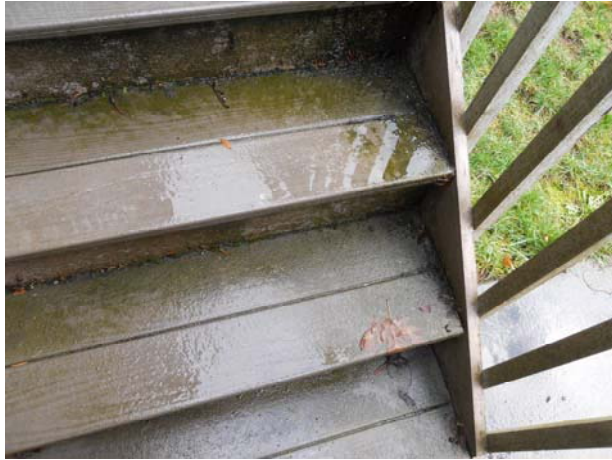
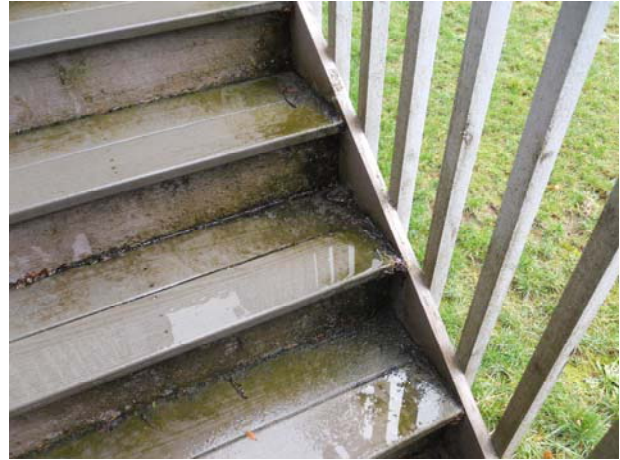
**50. Repair, WDO** :-> The back deck stair treads are not correctly installed: they are installed too close together so water is not draining through. This will lead to premature deterioration of the steps as well as a potential slippery surface. Installing new treads is recommended.
